CITY OF BALTIMORE WET WEATHER CONSENT DECREE SMOKE AND DYED WATER TESTING FORM		Page 1 of 4
Sewershed: Low Level Subsewershed: 44	Company: REI/DRAYCO	Date: 08/26/2008
Test Type: Smoke	Ground Condition: Dry: X Damp: _ Wet: _	Supervisor: E.R. Crew: 03
Manhole ID: S17K__023MH	Test ID: 1029-561	Notifications Made: __X__ Residents, Fire, 311
Field Sketch: (Show all manholes with numbers, blower placement location, sandbag or isolation locations, street names, building addresses and locations, defect locations and photograph numbers)

CITY OF BALTIMORE
SMOKE TESTING OBSERVATION SUMMARY
LOW LEVEL SEWERSHED
BALTIMORE CITY PROJECT 1029
REI/DRAYCO

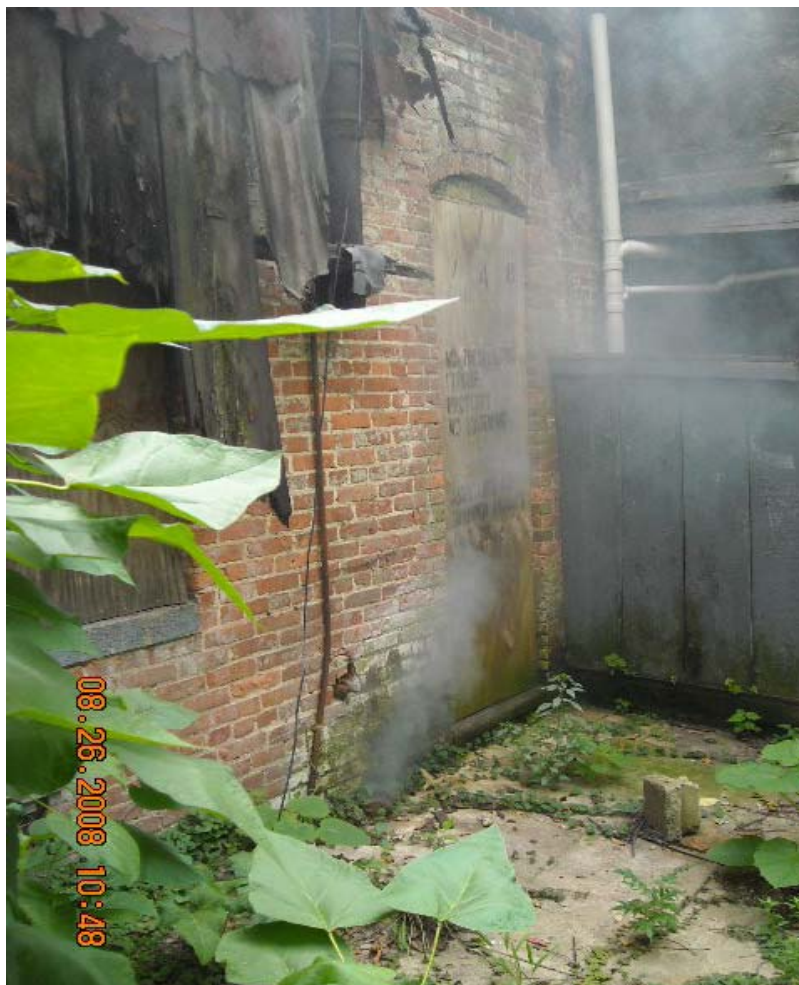
Photograph No: OB01-01
Filename: 1029-561_OB01-01.jpg

Unique Test ID: 561	Date: 08/26/2008	Basin: LL - 44	Manhole ID: S17K__023MH
Defect No: OB01	Supervisor: E.R.	Crew: 03	Dye Test Recommended: N
Location: 2449 FREDERICK AVE.			
Source Type: 03 Cleanout		Sector: 02 Private	
Location: 08 Yard - Back		Severity: 03 Moderate	Drainage Area: 0
Comments: ABOVE GRADE CLEANOUT MISSING CAP.

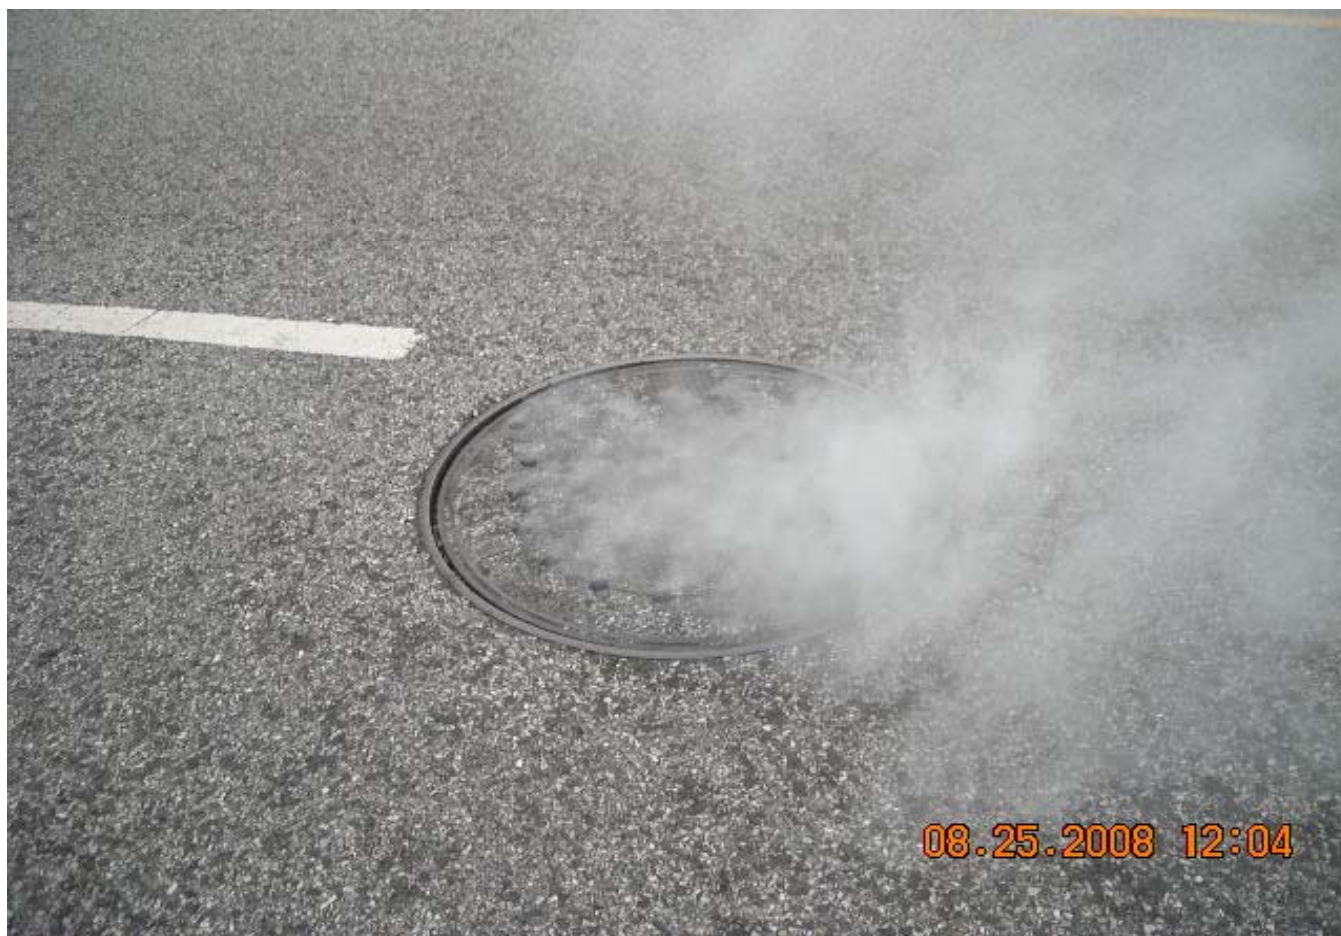
Photograph No: OB02-01
Filename: 1029-561_OB02-01.jpg

Unique Test ID: 561	Date: 08/26/2008	Basin: LL - 44	Manhole ID: S17K__023MH
Defect No: OB02	Supervisor: E.R.	Crew: 03	Dye Test Recommended: N
Location: S17K__013MH			
Source Type: 01 Main Sewer		Sector: 01 Public	
Location: 02 Asphalt		Severity: 03 Moderate	
		Drainage Area: 6	
Comments: MANHOLE S17K__013MH HAS STORM DRAIN LID.
